**Subject: Safety Recall 03V-280  
(Ford Number 03S03)**

**SUBJECT:** Advance Notification: Safety Recall 03S03:  
Certain 1999 through 2001 Model Year Explorer (4-Door, 2-Door, Sport, Sport Trac) and Mountaineer Vehicles Built with 4.0L SOHC Engines and Equipped with Factory Installed Speed Control -  
Speed Control Cable Inspection / Replacement

**SUBJECT:** Safety Recall 03S03:  
Certain 1999 through 2001 Model Year Explorer (4-Door, 2-Door, Sport, Sport Trac) and Mountaineer Vehicles Built with 4.0L SOHC Engines and Equipped with Factory Installed Speed Control - Speed Control Cable Inspection / Replacement

## CERTAIN 1999 THROUGH 2001 MODEL YEAR EXPLORER AND MOUNTAINEER VEHICLES — SPEED CONTROL CABLE INSPECTION/REPLACEMENT

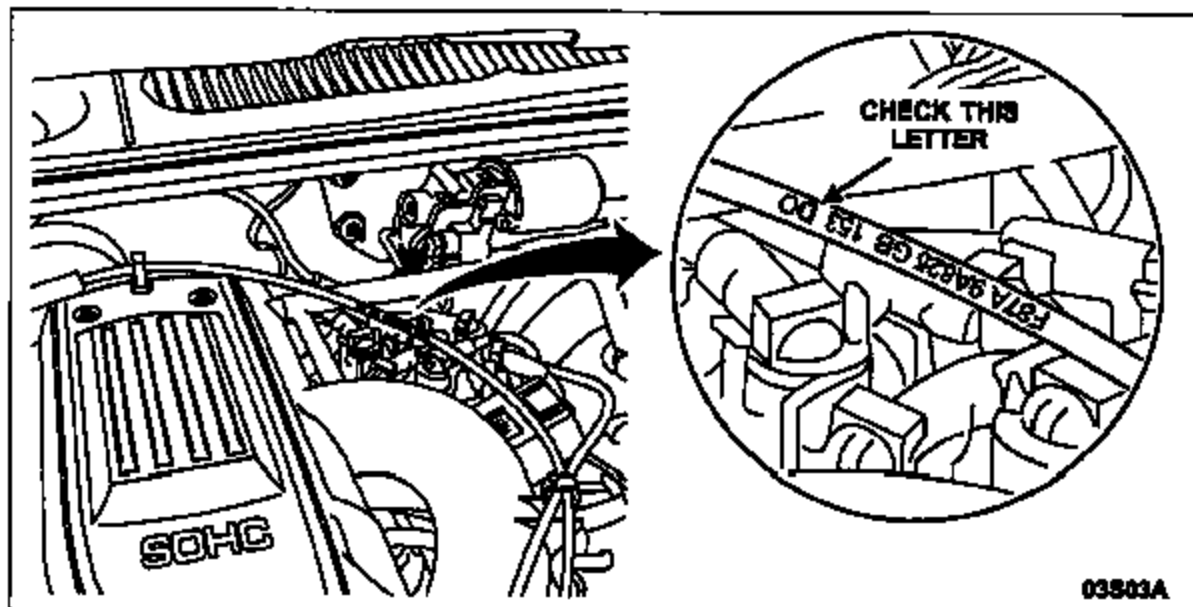
FIGURE 1

1. Locate the speed control cable identification number. Read the second to last letter. See Figure 1.
  - If the letter is a "T", no service is required. Release the vehicle.
  - If the letter is a "D", continue with this inspection.

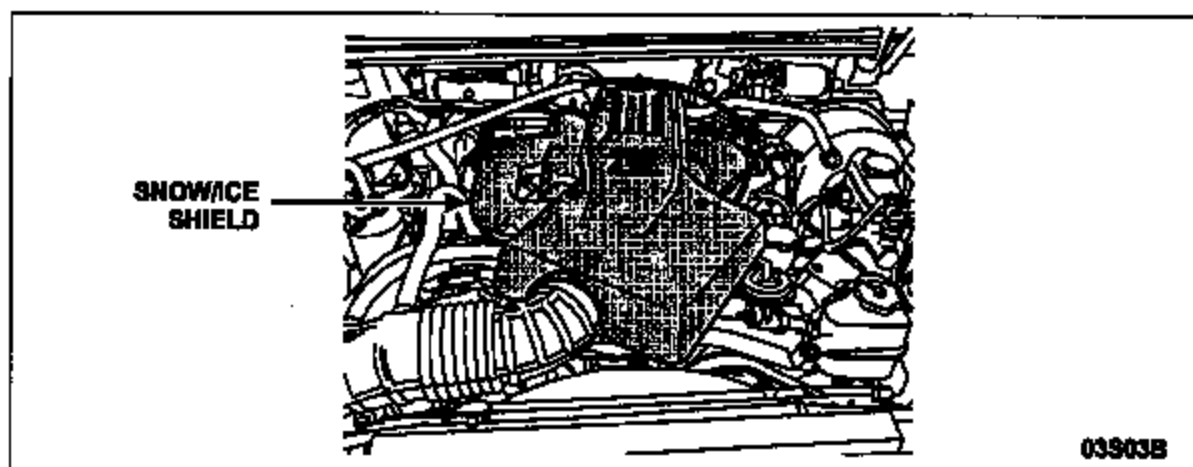
FIGURE 2

2. Remove the snow/ice shield. See Figure 2.

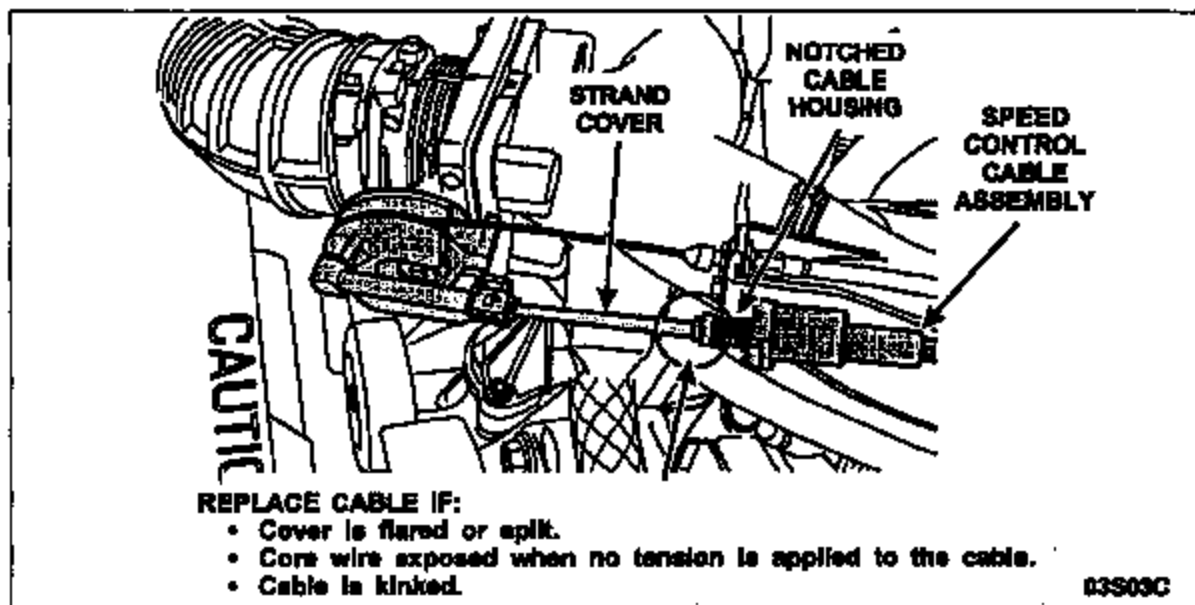
FIGURE 3

3. Visually inspect the cable for any of the following unacceptable conditions (see Figure 3):

- Cover flared or split.
- Core wire exposed when no tension is applied to the cable.
- Cable is kinked.

Replace the cable if any of the above conditions are found. For replacement and adjustment procedures, refer to Section 310-03, Vehicle Speed Control of the appropriate workshop manual.

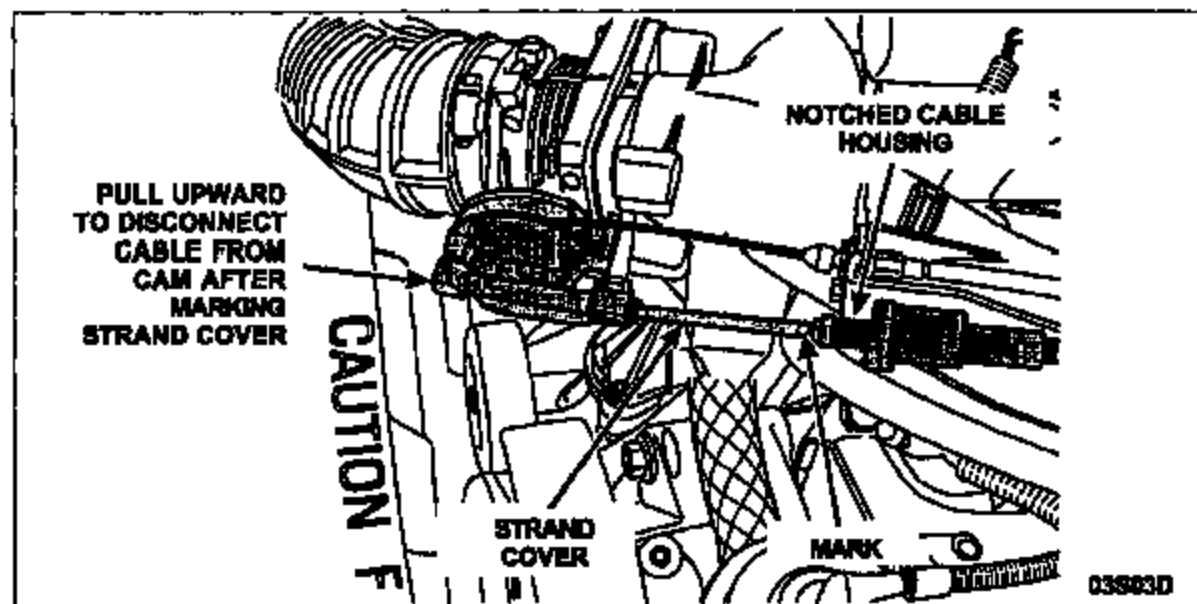
FIGURE 4

Clean the cable if necessary, then using a suitable marking device, mark the strand cover at the point where the cover enters the notched cable housing. See Figure 4.

5. Disconnect the speed control cable connector from the throttle body cam by pulling the connector upward. See Figure 4.

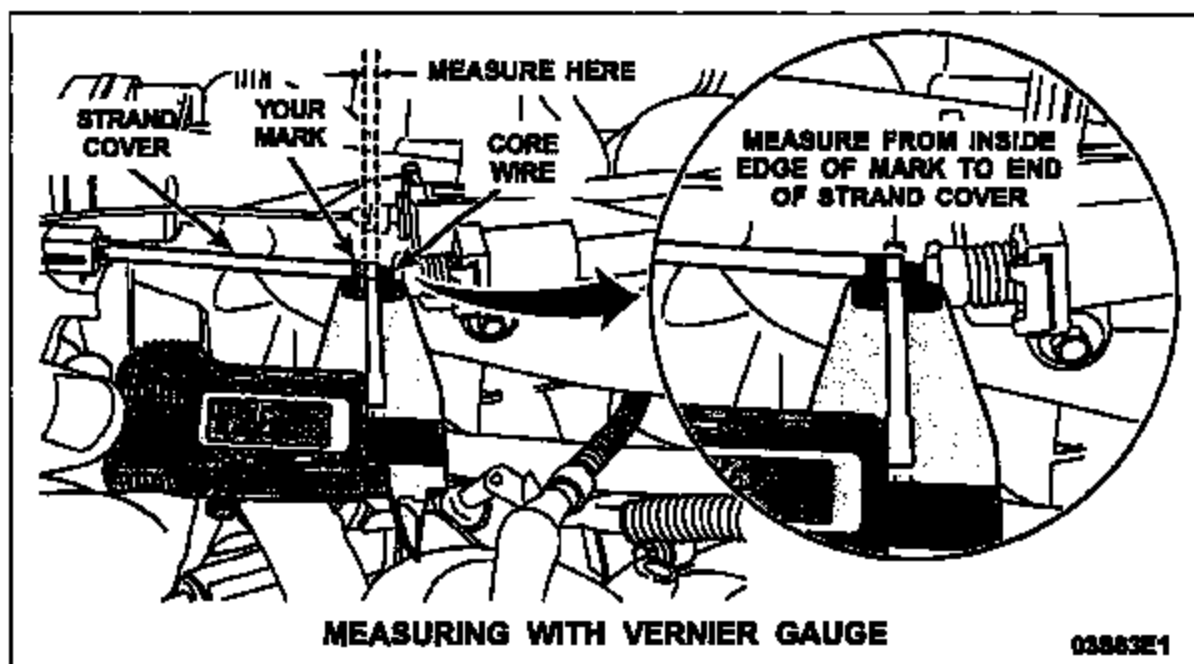
FIGURE 5

Pull the connector taut (toward the front of the vehicle). See Figure 5.

- B) If the strand cover is pulled out of the notched cable housing, using either the supplied 4 mm checking gauge or a Vernier caliper, measure the distance from the inside edge of the mark to the end of the exposed strand cover. Do not include the thickness of the mark when taking the measurement. See Figures 5 and 6.

- If the measurement is 4 mm (5/32-inch or 0.157-inch) or greater, no further service is required. Reattach the connector to the throttle body cam, install the snow/ice shield and release the vehicle.

- If the measurement is less than 4 mm (5/32-inch or 0.157-inch), the speed control cable must be replaced. For replacement and adjustment procedures, refer to Section 310-03, Vehicle Speed Control of the appropriate workshop manual.
